Manhole Inspection Summary

Manhole # S31OO1016MH

Insp Date: **4/14/07 10:12 AM**

Location Address: **4501 CHARLES ST**

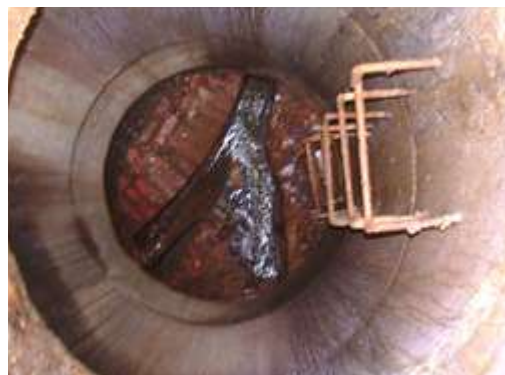
Top View

☒ **Debris** (not Condition related)

☒ **Deteriorated**

Bench deterioration and debris.

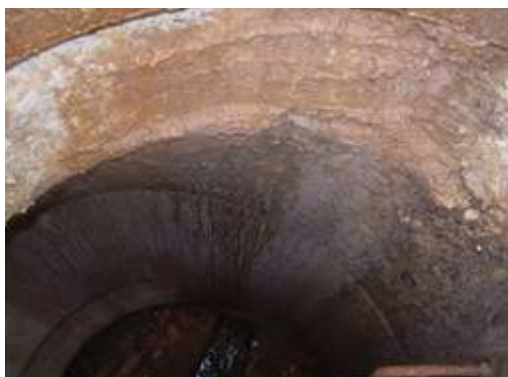
Defect

☒ **Leaks**

☒ **Joint**

☒ **Wall**

Frame leaks. Adjustment infiltration.

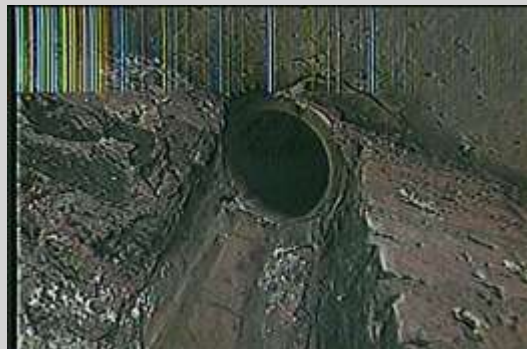
Pipe In @ 7 O'Clock

Pipe Seal Cond: **Cracked**
